THE RESTORATION OF THE SUNDIAL AT STUTTON HALL, SUFFOLK

HARRIET JAMES

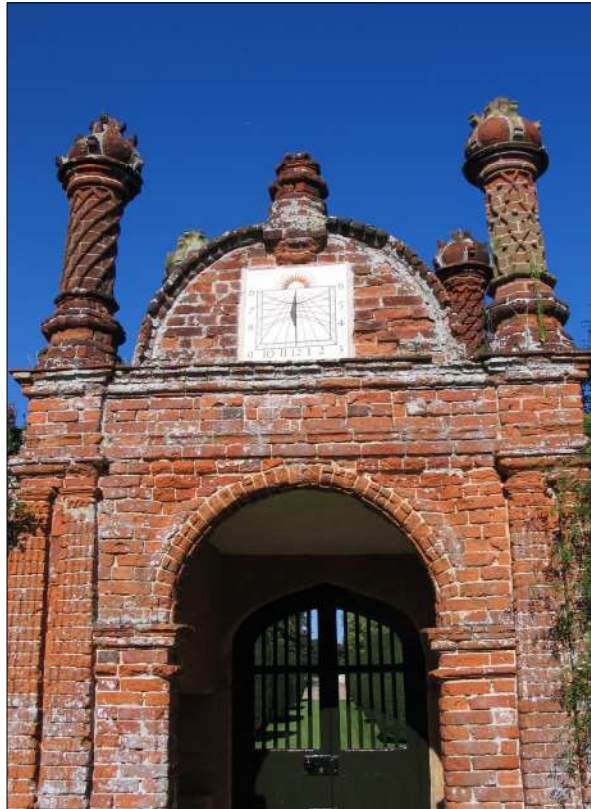
Fig. 1. The Tudor gateway at Stutton Hall with its restored sundial.

The sundial (BSS SRN 4490) at Stutton Hall is set into the semi-circular pediment of the south side of the Grade II* listed gateway which leads into a walled garden next to the house. The dial appears to be part of the original gateway.

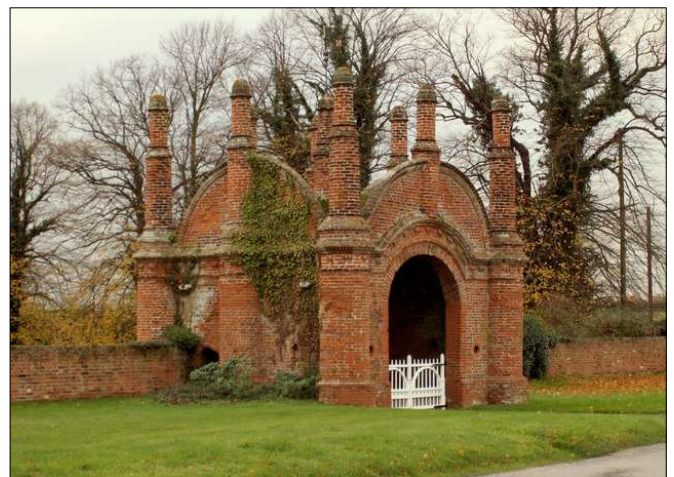
Fig. 3. The Stutton Hall sundial before restoration.

It could possibly be a later addition but the brickwork is built around the dial stone rather than cut away to fit it. Each brick course on the pediment has a different arrangement of brick sizes which accommodate the sundial. In contrast, the courses below the pediment are much more regular (see Fig. 3).

The sundial stone is wedged in place with bits of broken brick tile which match the thickness and colour of the tiles capping the moulding immediately below it. This again suggests that the dial is contemporary with the gateway.

Loose pointing around sundial was raked out and it was repointed with a 3:1 washed white sand and hydraulic lime mixture to match that used on the restoration of the brick pinnacles on the gatehouse and garden walls.

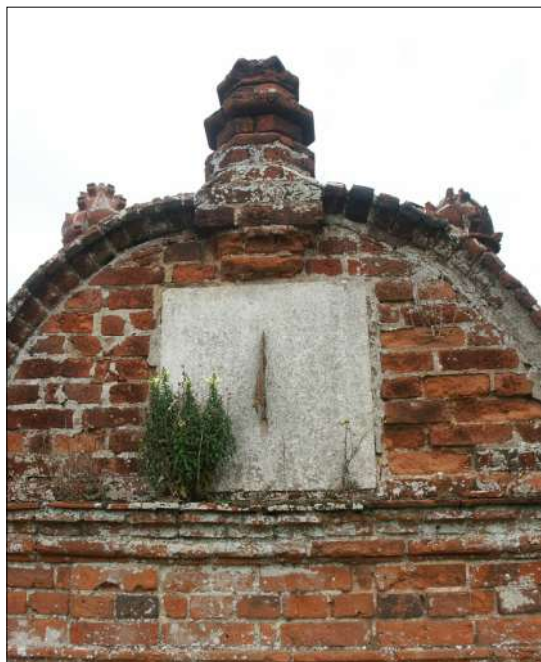
Fig. 4. Bruisyard Hall, Suffolk.

There is also a sundial (Fig. 4, BSS SRN 5573) set into the brickwork of the gateway at Bruisyard Hall, another Tudor house, about 15 miles north-east of Stutton Hall, near Saxmundham. That Hall was originally an Abbey of the Order of the Poor Clares, dissolved by Henry VIII in

1539 and given to Nicholas Hare.⁹ The dial has been heavily restored but the remains of the gnomon show a fimbriated bottom edge similar to that at Stutton Hall and a similar positioning of the hourlines low on the stone.

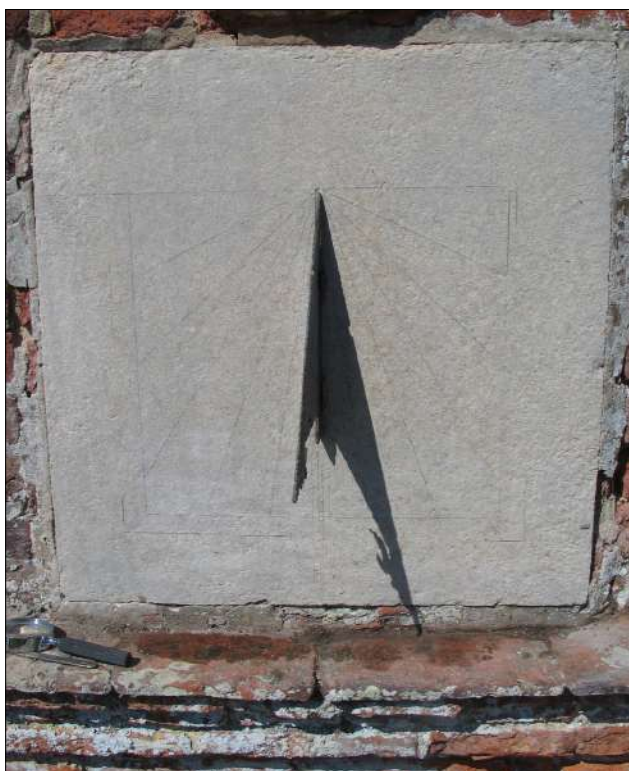
Fig. 5. After cleaning. The border and hour lines are enhanced with pencil.

The sundial (Fig. 5) is on a 24" square piece of high-quality, hard, fossiliferous limestone, 1" thick. The stone is in good condition with no cracks. It is similar to Purbeck limestone but could have been brought by sea from France.

At first sight the sundial appeared to be blank. I started to clean away the coating of three different kinds of lichen on the limestone using water and a toothbrush. A symmetrical set of radiating hour lines and a border appeared (highlighted with pencil in Fig. 5). Each line was 2-3 mm wide, rounded in profile and raised from the surface by about 1 mm. These lines may have been scored into the stone when they were laid out. As the dial was painted the scored lines perhaps filled with paint which protected them from the elements while the stone surface around them eroded. Samples of lichen were inspected under a microscope but there was no sign of any remaining paint pigment. The lichen may have metabolised the pigment over the centuries.

The original hour lines are correctly delineated for a dial facing due south. It was interesting to discover that the layout is such that the lines for 9 am and 3 pm exactly meet the lower corners of the rectangular border. The nodus is positioned so that a declination curve for the winter solstice, if extended, exactly meets the upper corners of the border. This suggests that the maker of the sundial was experienced in sundial design.

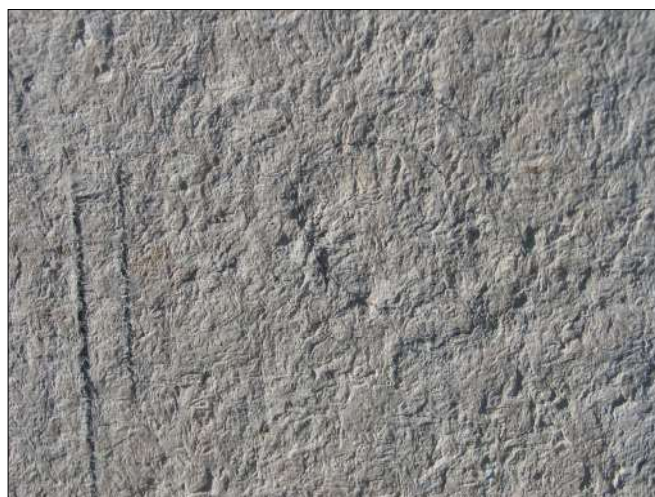
The gatehouse faces 3° East of due South. The easterly edge of the sundial stone is canted out from the brickwork and the dial faces within 0.5° of due South. There appears to have been some movement in the structure of the gatehouse as the stone now reclines by 2.77° and sags by 0.79° on the Eastern side.

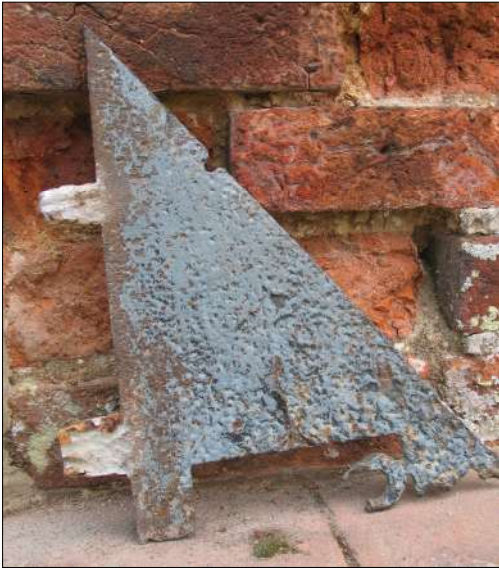
Fig. 7 (far left). The gnomon removed for realignment and repainting.

The iron gnomon plate (Fig. 7) is pitted, 2-3 mm thick, with a distinctive semi-circular nodus cut out of the upper edge. Its two tenons are fixed into slots in the stone with lead plugs. The decorative fimbriation cut out of the lower edge of the plate is partly broken or corroded away. Before restoration, the upper edge of the gnomon plate was tilted by 2.44° to the west of vertical.

The misalignment of the sundial caused by movement in the structure of the gatehouse produces some minor inaccuracies in time-keeping in the early morning and late afternoon. As it is not clear how the sundial stone is built into the brick gable and how much it is supporting or is supported by the brick, realigning the dial could have involved major rebuilding. It was decided to correct only the angle of the gnomon by removing the original lead plugs holding it into the sundial stone. Some fibrous material was removed with the plugs suggesting that the gnomon had originally been secured with wooden wedges before lead was poured in on either side to fix it. The gnomon was cleaned of an old grey undercoat and repainted with rust-inhibiting black paint, then reset by hammering the original lead back into the stone and adding some new lead.

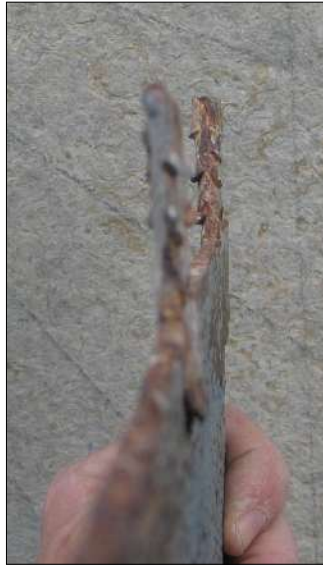
Fig. 8. Notched tenons on the gnomon.

The tenons on the gnomon had been notched by their original maker to provide a better key for the lead (Fig. 8). The tenons were bent away from the main plate suggesting that the gnomon had been knocked or deliberately bent at some stage.

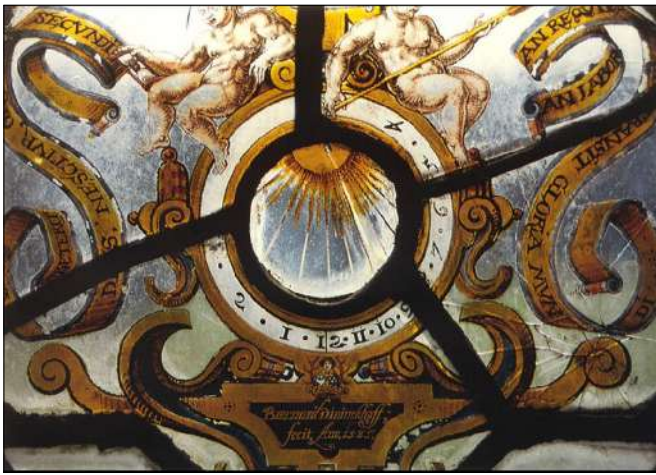
Fig. 9. The stained glass sundial at Gilling Castle, Yorkshire which is dated 1585.

The shapes of the hour numerals imitate those used by Hans Holbein to date his portraits of Tudors of the 1530s and 40s. I also looked at the numerals, colours and a sunburst on one of the earliest stained glass English sundials of 1585 from Gilling Castle, Yorkshire (Fig. 9). A sunburst was added to the Stutton Hall sundial design in the absence of any clear evidence of a date or motto which may have been painted across the top of the sundial.
